June 6, 2014

Re: Condition Survey of Existing Masonry Walls
at 907 Congress, 909 Congress, and 911 Congress

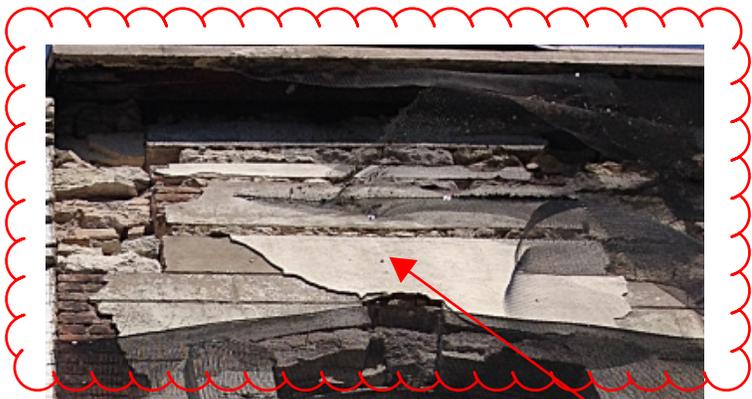
Failed Masonry
At Roof

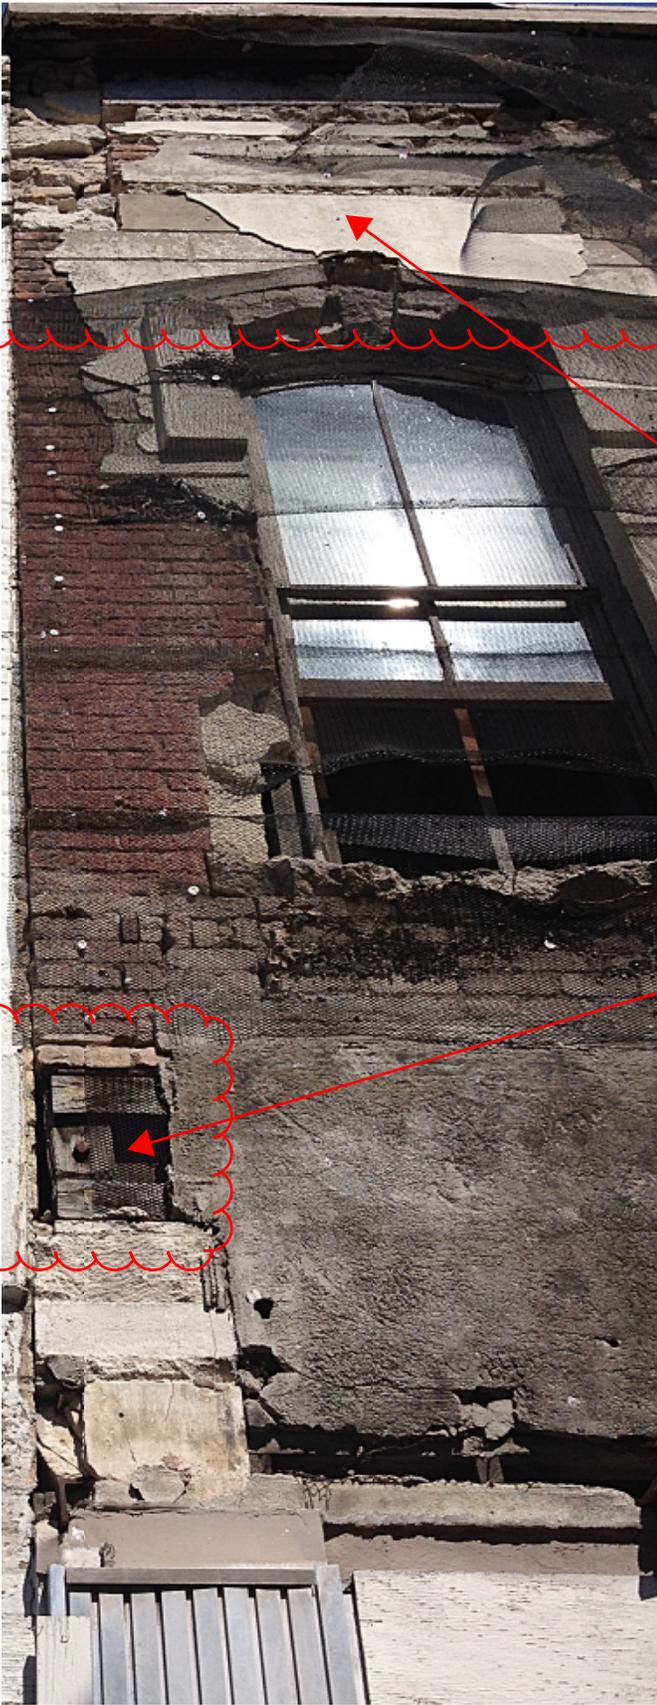
Failed Masonry

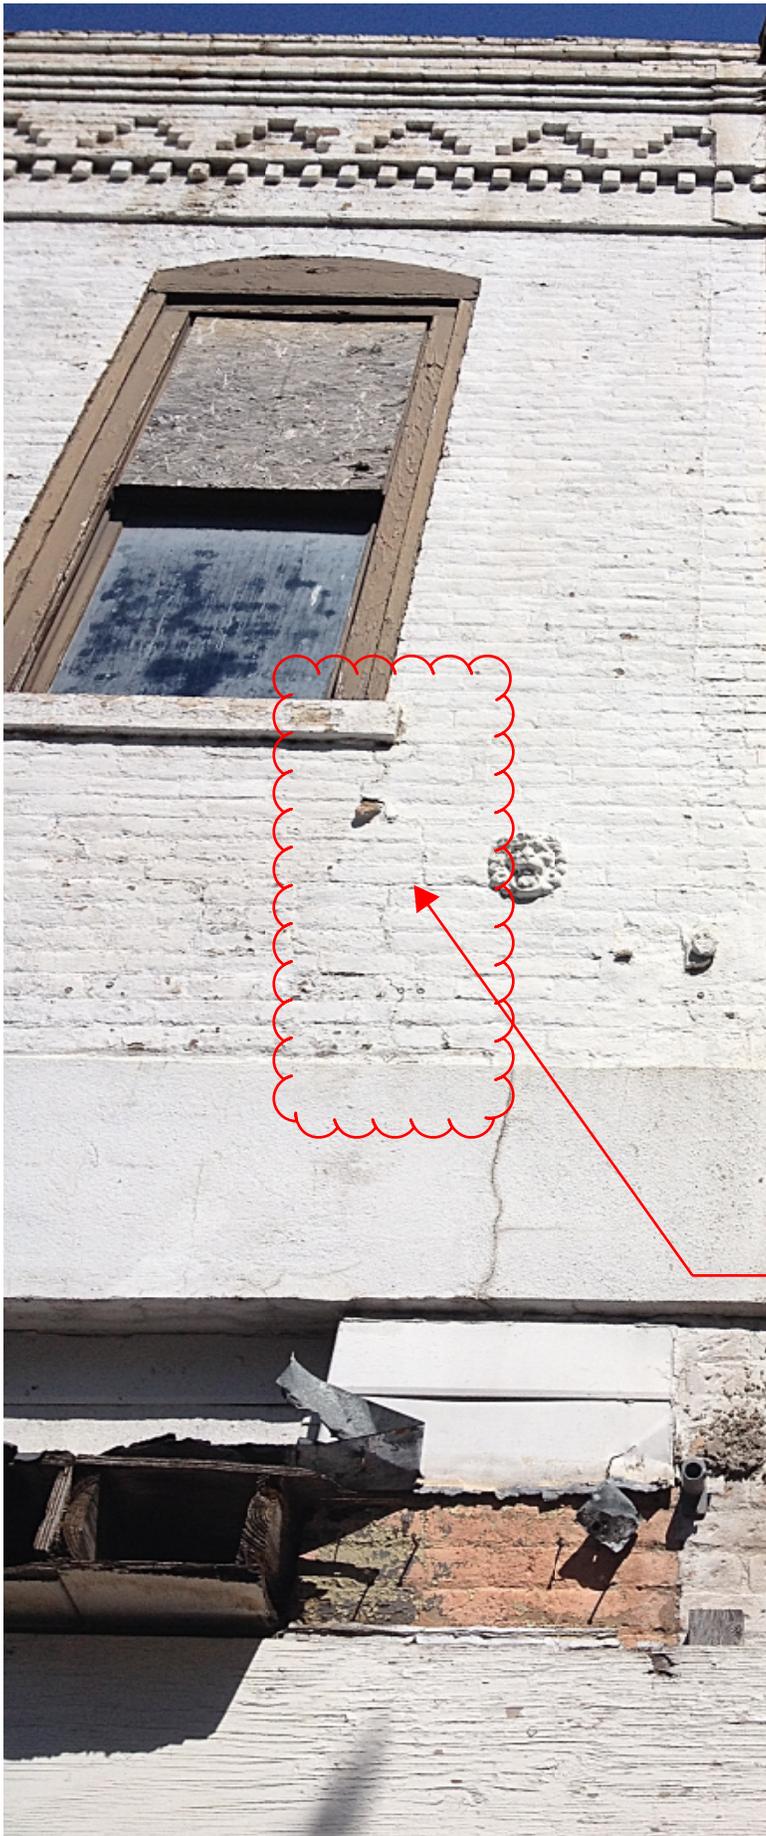
Shear Crack
Through Masonry

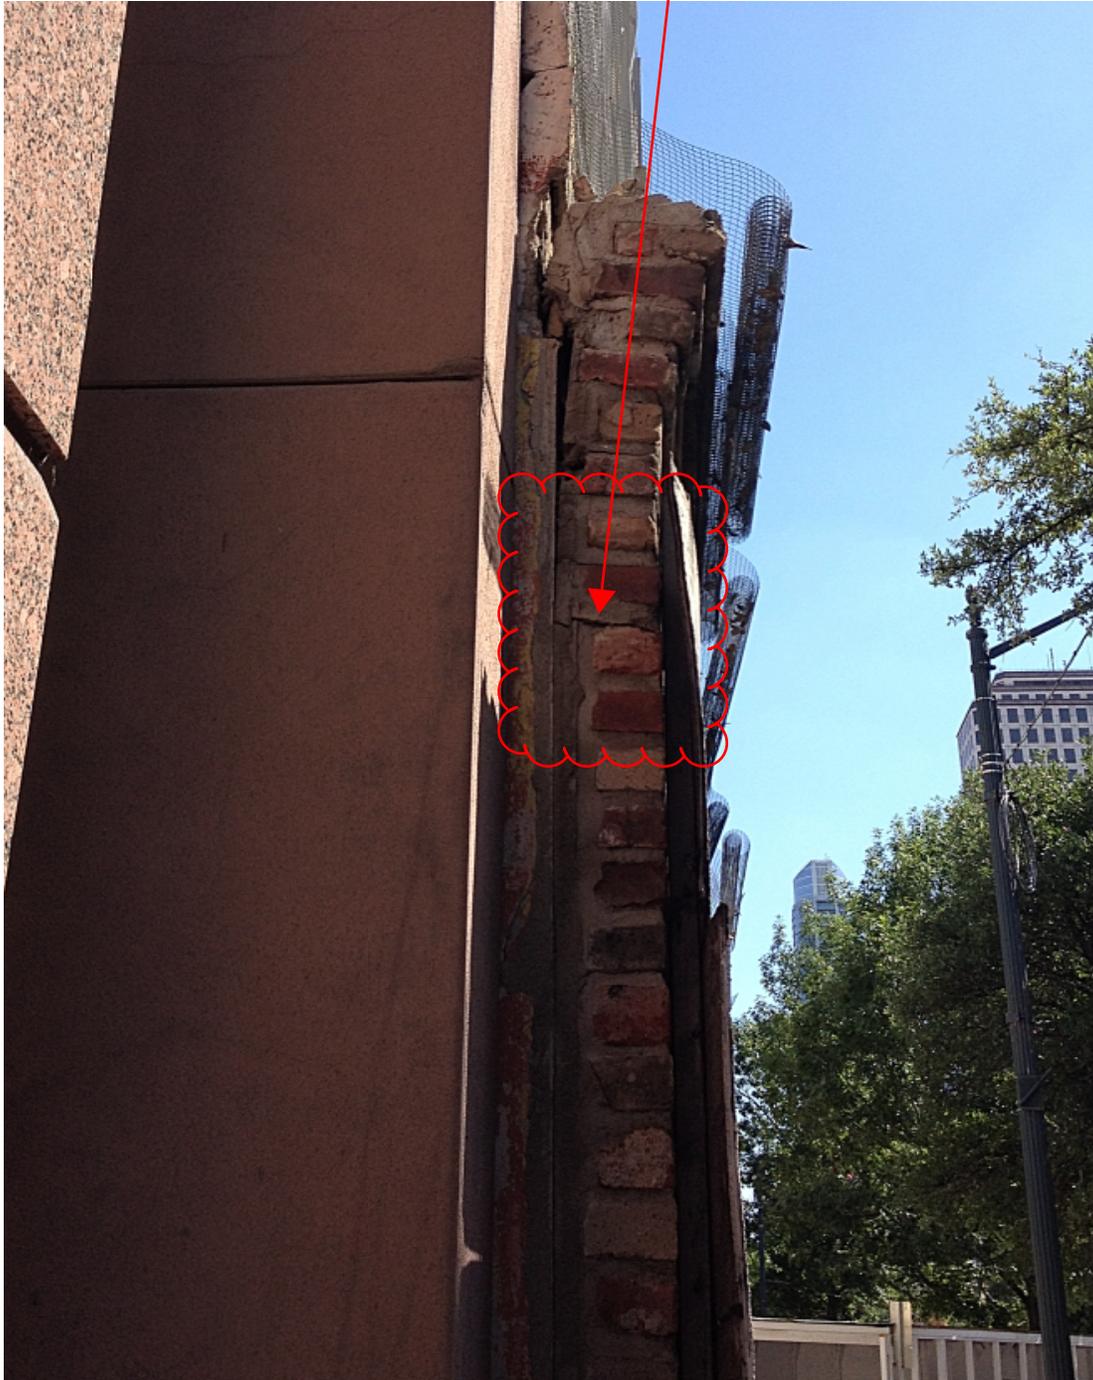
Failed Masonry

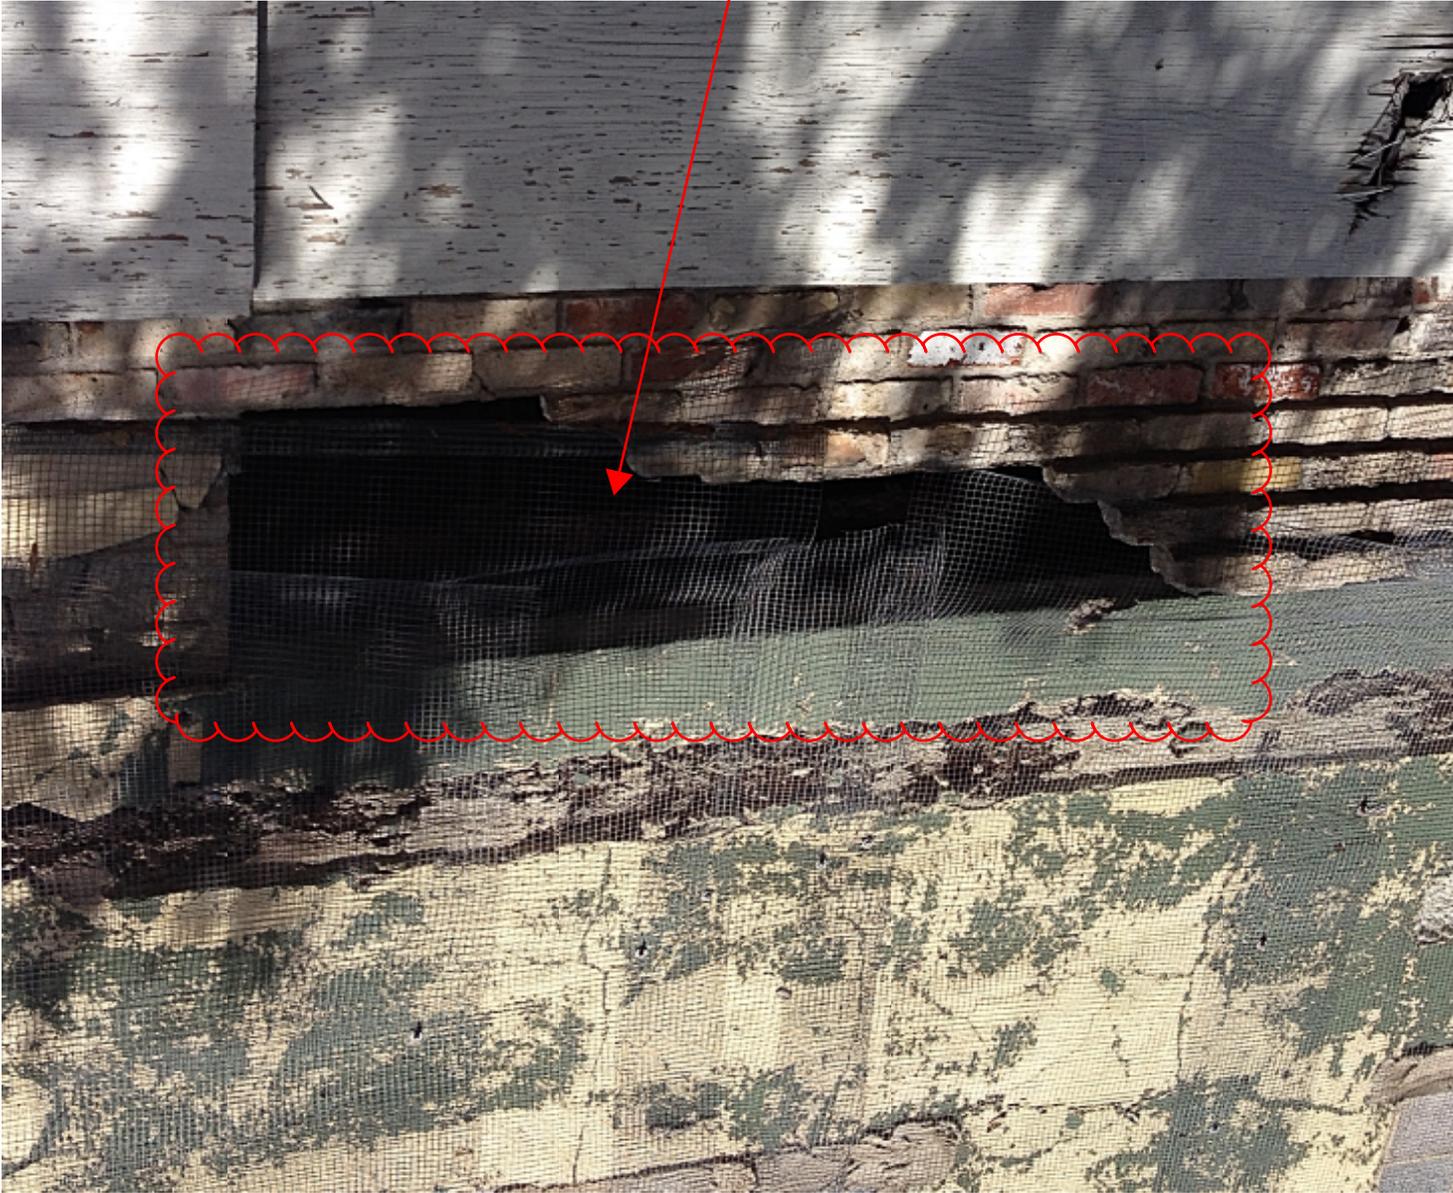
Failed Masonry
On Lower Level
